# Hydrologic and Water Quality Monitoring on Turkey Creek Watershed, Francis Marion National Forest, SC

A South Carolina Water Resources Conference Presentation  
*October 15, 2008, North Charleston, SC*

# TURKEY CREEK WATERSHED

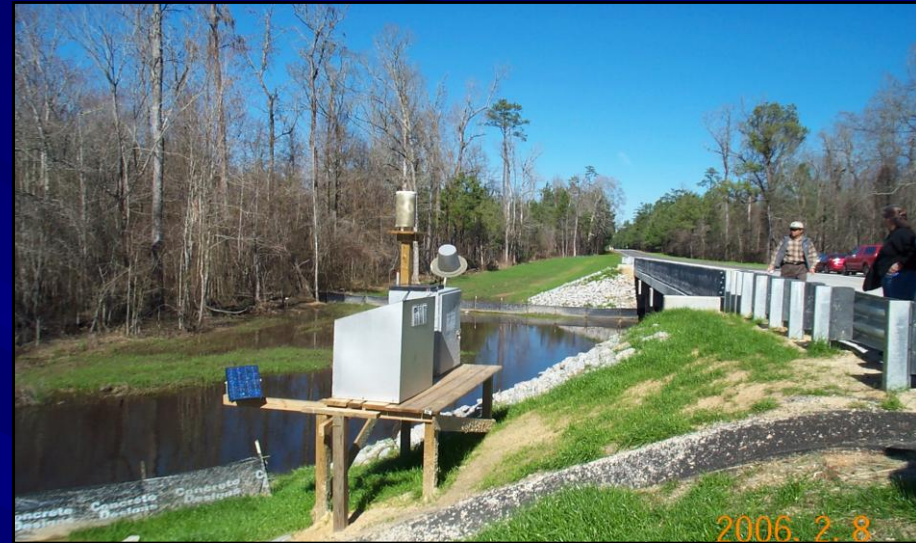
- Stream flow: 2005 – (USGS, CofC)
- Rainfall: 2005 – (USGS, CofC, and FS)
- Complete weather: 2005 – (FS)
- Shallow groundwater: 2006 – (FMNF, FS)
- Deep groundwater: 2005 – (CofC)
- Water quality: 2006 – (FS)
